UNITED STATES ENVIRONMENTAL PROTECTION AGENCY

Re: Cow Palace Dairy Lagoon 1 Closure Report
Administrative Order on Consent ("Consent Order")
Docket No. SDWA-10-2013-0080
Yakima Valley Dairies, Washington

- Cow Palace Dairy Lagoon No. 1 and Safety Debris Catch Basin Completion Report ("Report") (March 31, 2020)

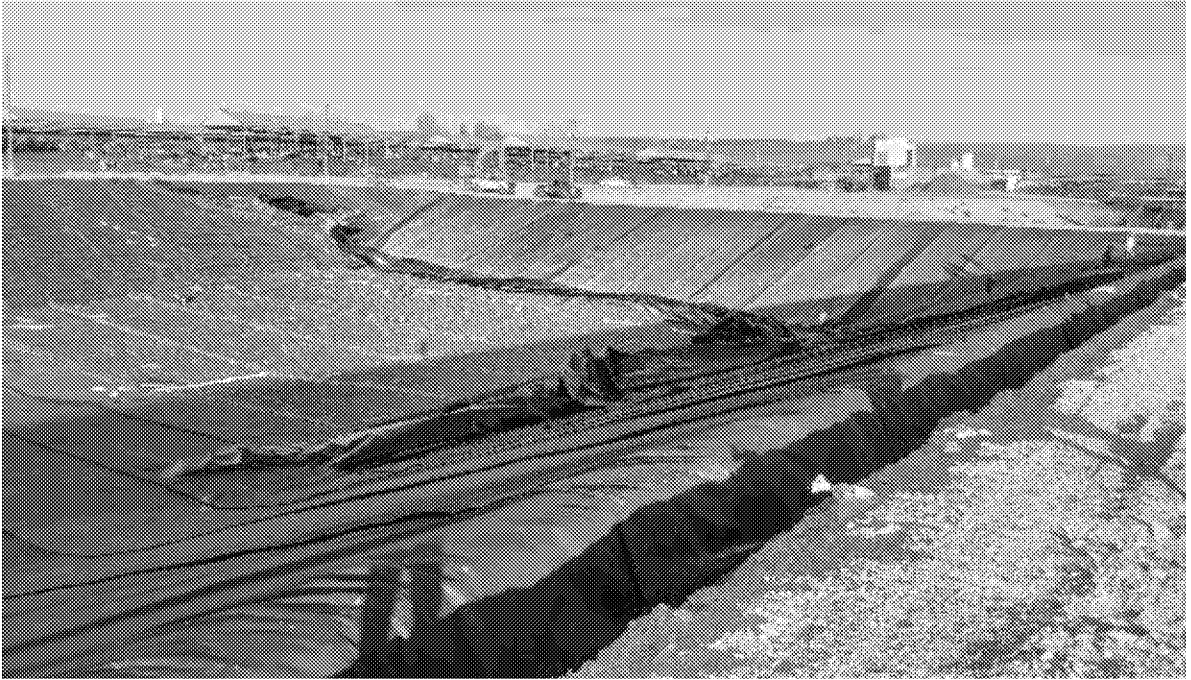
IMG_082510.JPG

The catastrophic windstorm "blowout" of the "completely installed" primary (lower) liner is buried and scattered in photos, tables and drawings contained in appendices of the Report. It appears the liner was ripped in two by the wind along a 350-foot tear that ran east-west across the middle of the liner. These two photos and captions are copied from the Report:

50-mil liner blowout at north end of Lagoon 1
November 29, 2019 at 08:25:10 AM

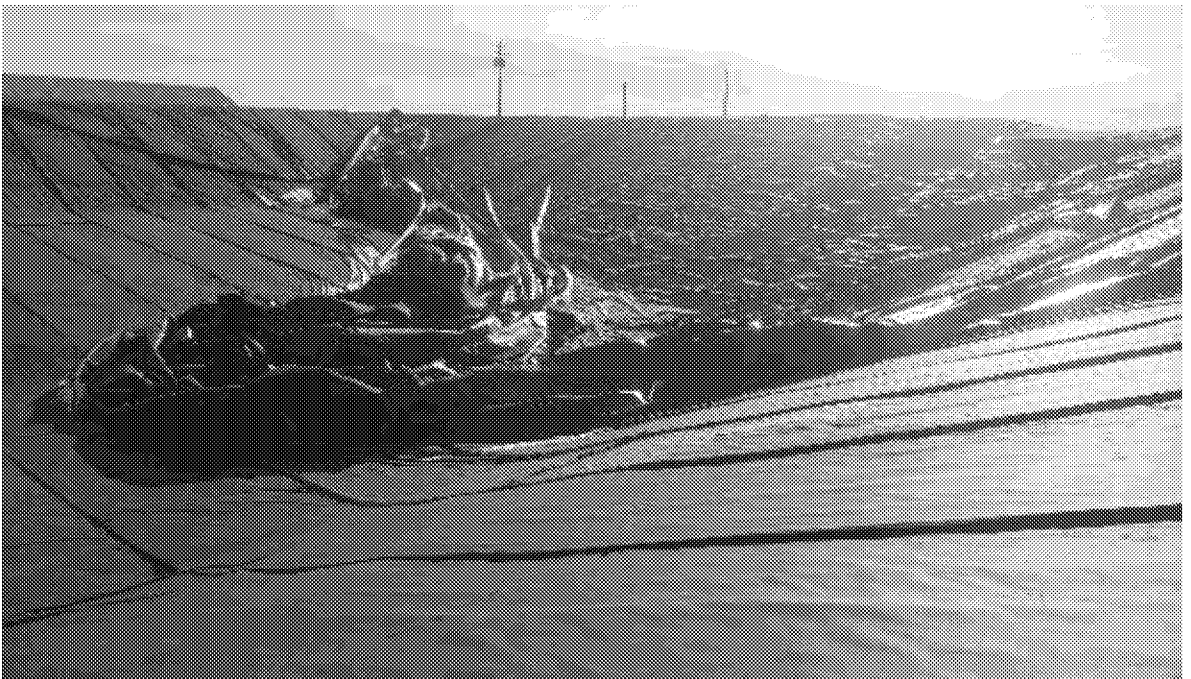
IMG_101010.JPG

50-mil liner blowout at southern half of Lagoon 1.
November 29, 2019 at 10:10:10 AM
